LEVEL II  
**SPEEDWELL DAM**

**NJ 00359**

**PHASE 1 INSPECTION REPORT  
NATIONAL DAM SAFETY PROGRAM**

May, 1979

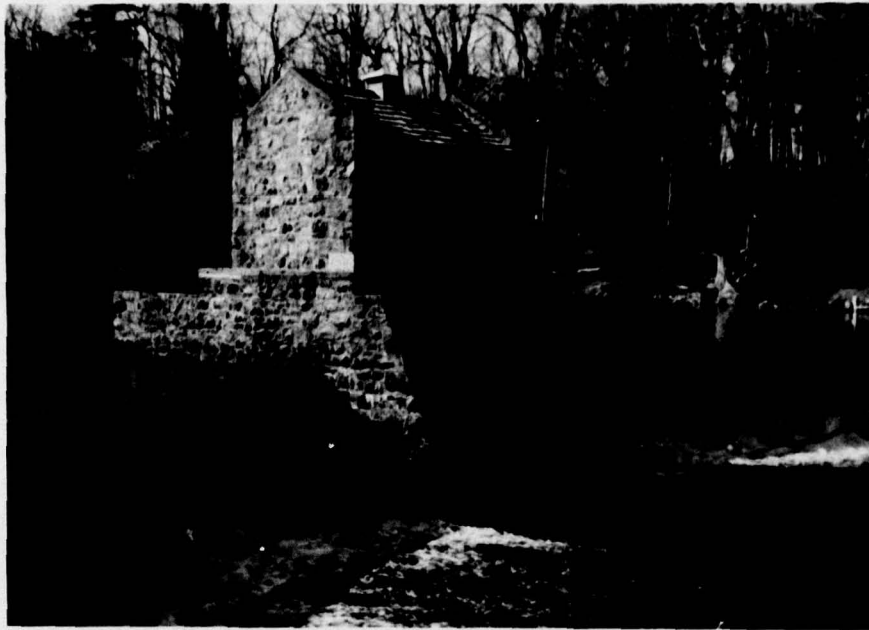
PHOTO 1

The north and south spillway sections appeared level and horizontally aligned in agreement with the construction drawings. Most of the spillway could not be closely observed due to overflow; however, the downstream face appeared to be in good condition where it could be observed. The stone masonry wall, comprising the center section of the dam where sluices are located is severely deteriorated at the water line on the upstream side. It appears to be in good condition on the downstream side. The outlet works training walls appear to be in generally good condition; although one stone on the downstream side is displaced. The spillway training walls

DOWNSTREAM FACE OF SPILLWAY AND GATEHOUSE

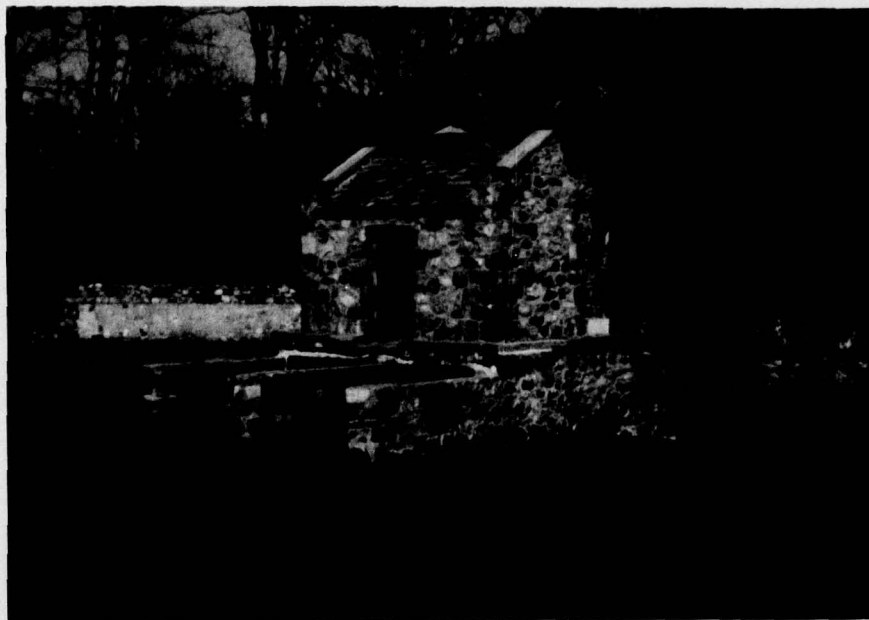
PHOTO 2

The gatehouse walls and roof are in good condition. The concrete deck slab is in generally good condition although its

upstream end is severely spalled. No gatehouse door is in place. The two gate operating mechanisms inside the gatehouse appear to be in good condition; one is slightly rusted and the other has been painted. The two mechanisms are operated manually with a wheel or key which was not in place at the time of inspection.

UPSTREAM VIEW OF GATEHOUSE

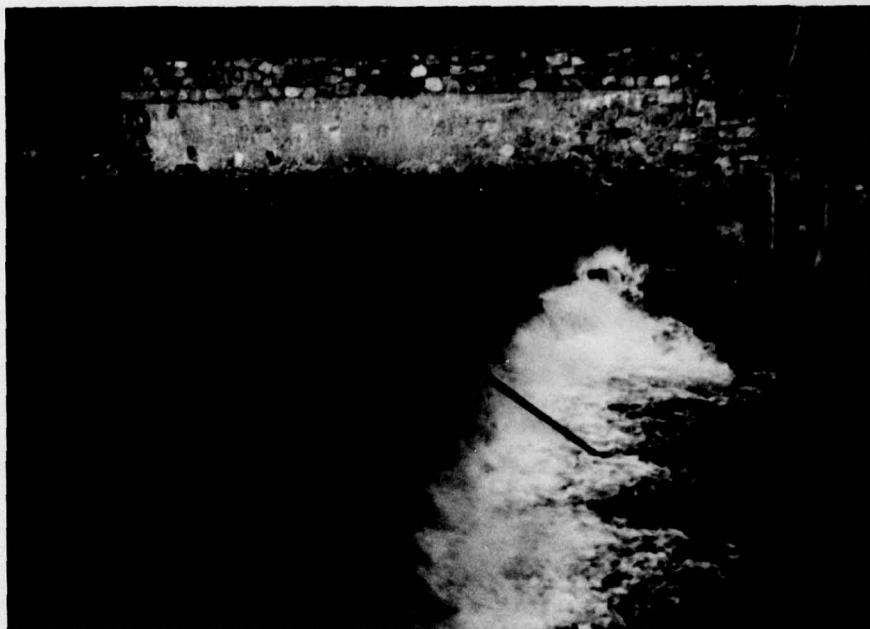
PHOTO 3

NORTH SECTION OF SPILLWAY CREST

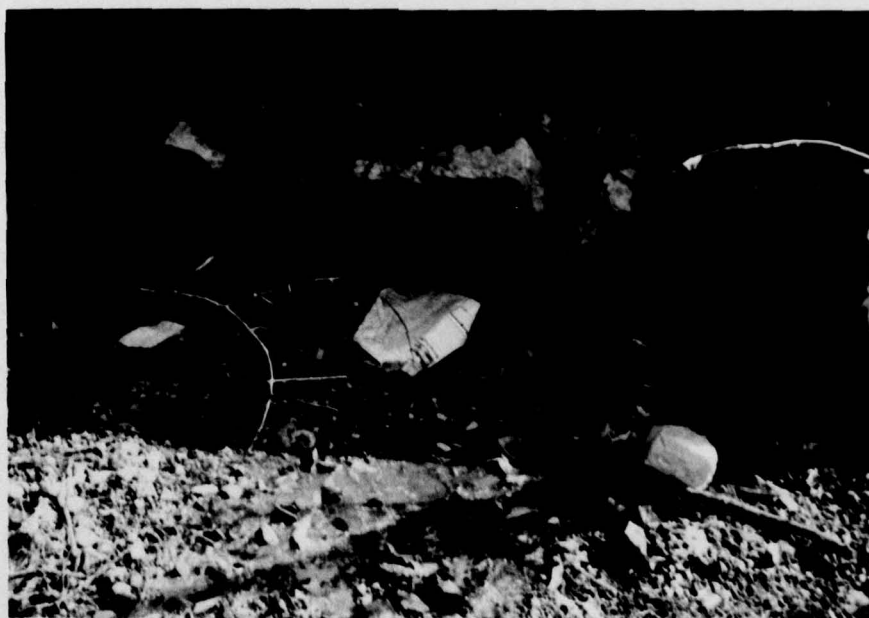
PHOTO 6

Four areas of seepage were observed discharging from the stone training walls along the downstream channel. Two of the areas are located in the south training wall and two in the north training wall. At the south training wall, seepage was observed flowing as a trickle through the wall at one point and from its base at another point. This latter seepage flow contained orange silt. At the north training wall, the two seepage areas were manifest as wet areas with no observable flow.

The seepage appears to be similar to that noted in the inspection report prepared in 1944. The severity of the seepage cannot be precisely determined within the scope of this Phase I evaluation. However, the seepage does not appear to be an indication of immediate structural instability.

SEEPAGE AT BASE OF SOUTH TRAINING WALL

Arrangements should be made in the near future to monitor the observed seepage in order to determine its effect on the structural stability of the dam. If necessary, measurements should be made by the use of appropriate instrumentation. The monitoring should be performed by a qualified professional engineer.

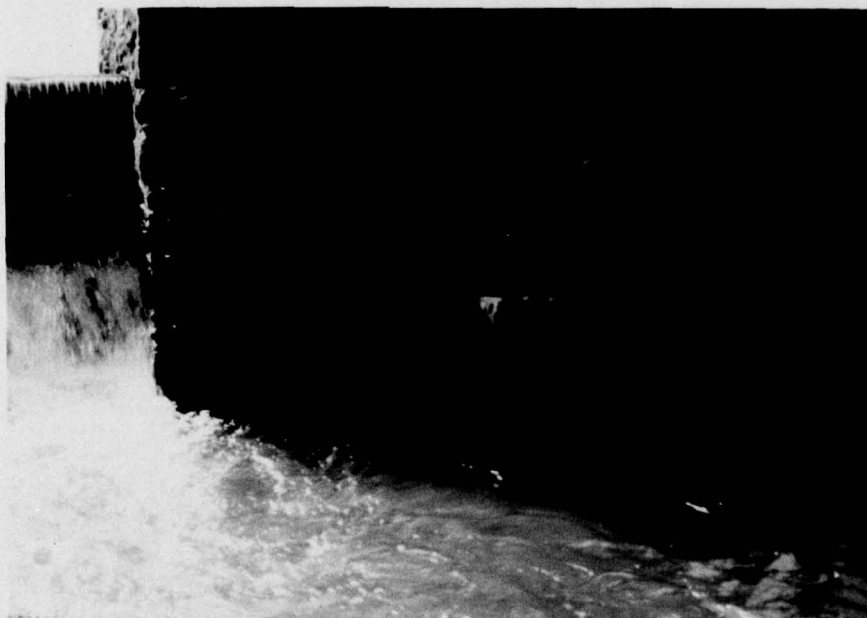
PHOTO 8

The gate lift stems are severely rusted at the water line causing significant reductions in cross section. The gates could not be observed completely but appeared to be in good condition.

DOWNSTREAM VIEW OF GATES

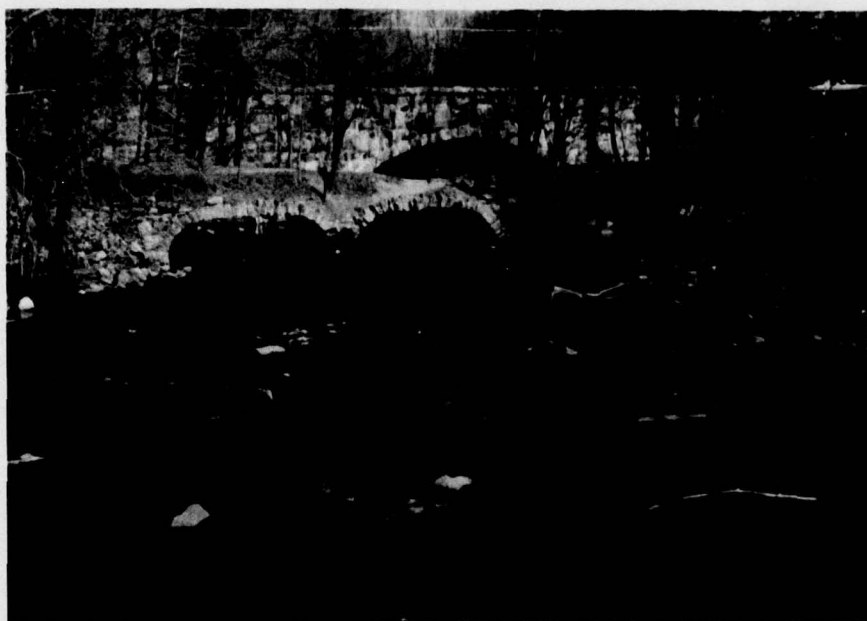
PHOTO 10

The training walls along the sides of the downstream channel are undermined. The walls should be renovated in the near future to eliminate this condition.

The spillway discharges into the Whippany River which in the vicinity of the dam is a wide well defined stream. Immediately downstream from the dam large accumulations of rocks and small amounts of debris comprise a minor obstruction to the flow of water. Approximately 150 feet downstream an old and deteriorated

Between the dam and the stone arch bridge the downstream channel banks are stone walls remaining from structures relating to the previous dam. They now serve as extensions of the spillway training walls. These walls generally are in good condition although they are undermined in some areas.

DOWNSTREAM CHANNEL AND BRIDGES

(3). The training wall along the sides of the downstream channel should be renovated to correct their undermined condition.
